MEMORANDUM

Site Assessment: Certain-Teed-Maline Creek Site. Bellefontaine Neighbors, St. Louis County, Missouri

TDD#: T07-9209-003 EMOO307SBA

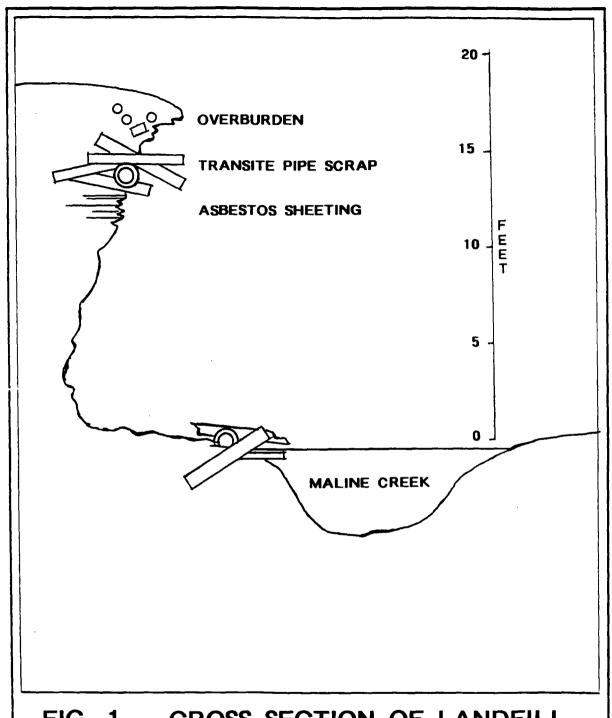
FIG. 1 CROSS SECTION OF LANDFILL EXPOSED AT MALINE CREEK

- * The transit pipe is exposed at a cut bank of the Maline Creek where the creek bends from a northwest-southeast direction to a nearly east-west direction (refer to Site Map).
- * The bank where the pipe is exposed is approximately 15 to 20 feet high and from 150 to 200 feet in length (refer to Site Map and Fig. 1).
- * The landfill, where exposed, consists of three distinct layers (refer to Fig. 1 and Photolog). The first layer, approximately two feet thick, is comprised of a soil cover mixed with pipe fragments and connector rings. The second layer, approximately two to three feet thick, is comprised almost exclusively of transit pipe fragments and connector rings with no apparent fill material. The third layer, approximately two feet thick, is comprised of asbestos sheeting, some insulation material, and fill.

* The top two layers overhang the bank approximately two to three feet. There are areas where cave-ins and slumping have occurred, leaving transit pipe and debris near the edge of the creek or in the creek itself (refer to Fig. 1 and Photolog).

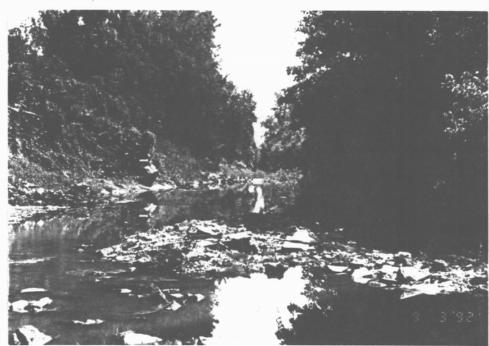
Frame No. : 1 Direction : SE

Site overview, looking

downstream

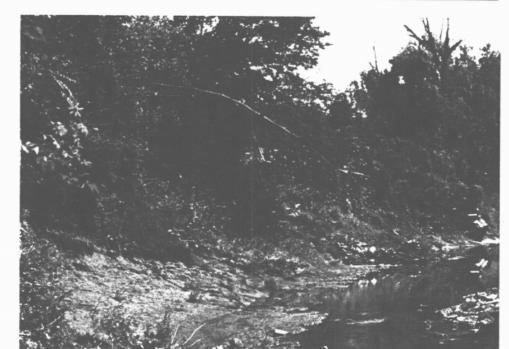
Frame No. : 2 Direction : SE

Overview of bank, downstream

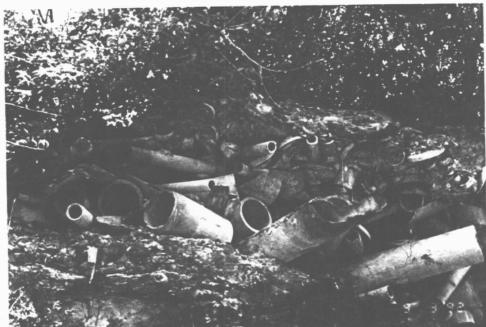
Frame No.: 4
Direction: NE

Top six feet of bank

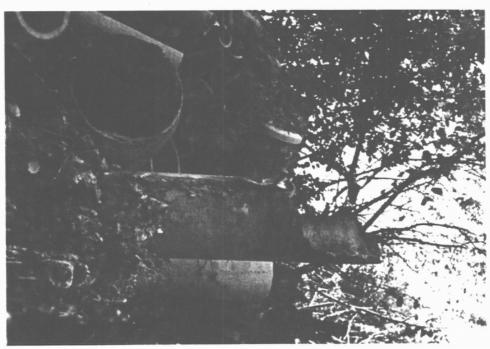
Transite pipe protruding from

bank

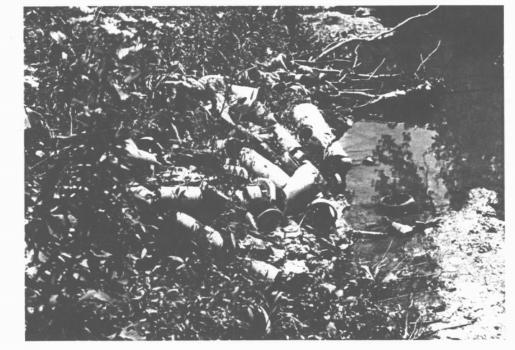
Transite pile near creek

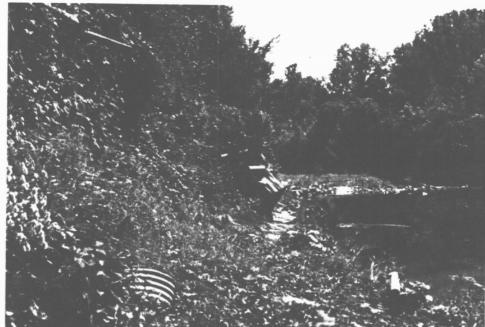
Frame No.: 8 Direction : SE

Transite pipe/fallen stump

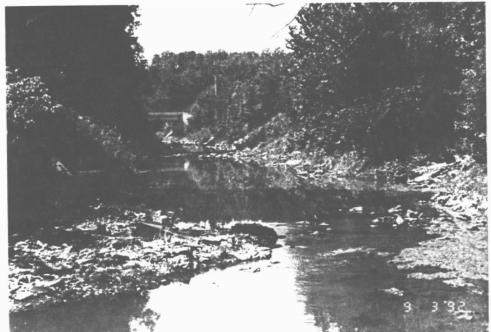
Frame No. : 10 Direction : W Comments :

Looking upstream toward bridge over Maline Creek at

Bellefontaine Rd.

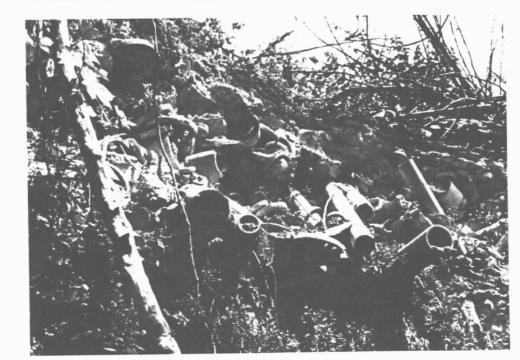
Serial No.: 1063023 Frame No.: 12

Connector rings, NE bank
